*Proceedings of the 4th Biennial of
Architectural and Urban Restoration, BRAU4
host of the Itinerant Congress
Hidden Cultural Heritage: Under Water,
Under Ground And Within Buildings
15–30 April, 2018.*

Geological, Chemical and Structural Research Regarding the Rehabilitation of the Drystone Rainwater Cisterns of Epano Mirabello Region, Crete

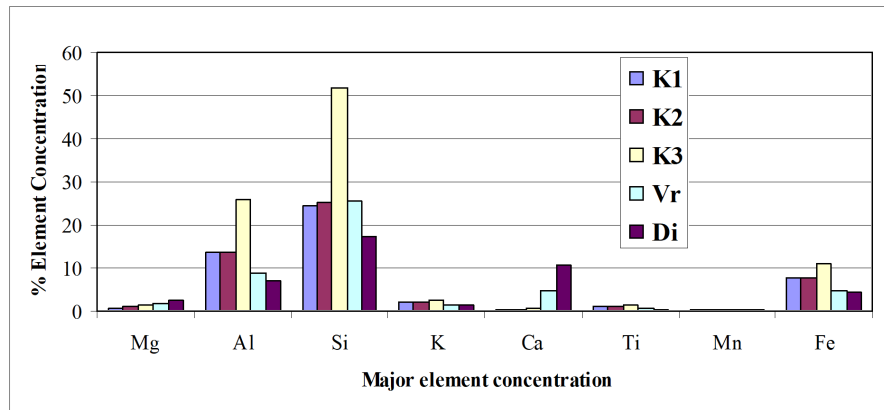
Figure 2: Major element concentration in the soils from Kourounes (K1-K3), Vrouxas (Vr) and Dilakkos (Di).

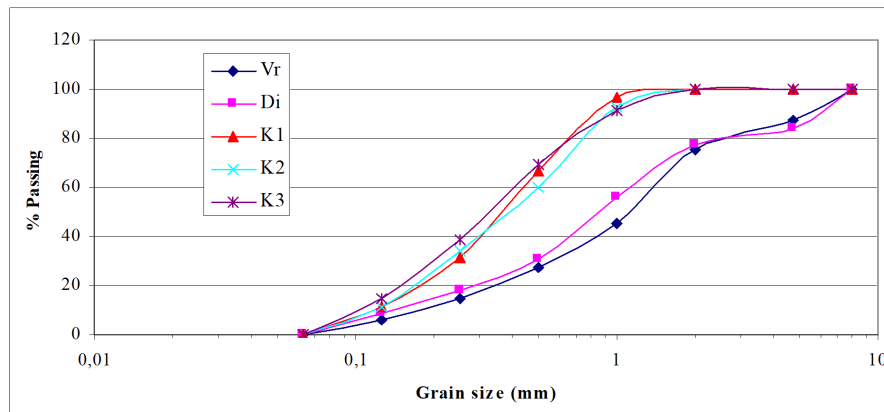
Differences in the mineralogical and chemical composition were also associated with differences in the soil grain size distribution, as is illustrated in Figure 2. The soils K1-K3 with a high clay content contain fine aggregates with diameters lower than 1 mm, while the other two soils exhibit grains with size lower than 5 mm. These grain size distributions classify the Kourounes soils as uniformly distributed sands, while the other two soils can be considered as well distributed. The well distributed soils contain both fine and coarse grains which play an important role into the water filtration. The uniformly distributed grains with a high clay content contribute to the retention of water and, therefore, a very common phenomenon is the water stagnation.

Figure 3: Grain size distribution of the soils.

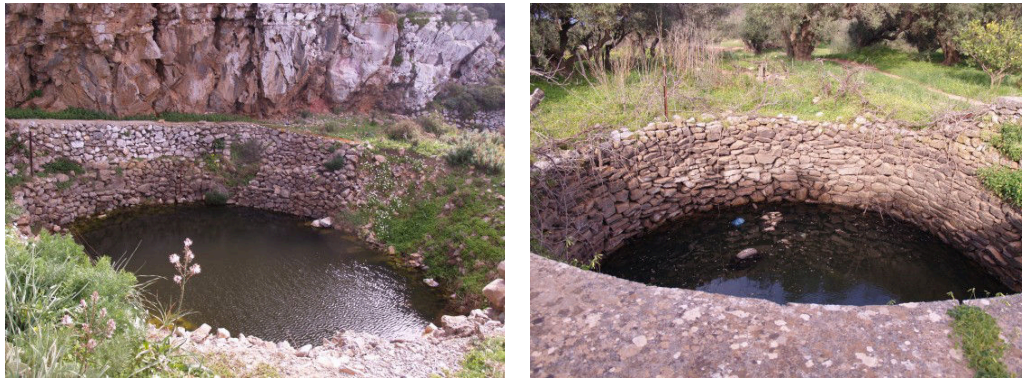
Figure 4

(a) Large cistern in Dilakko, where a large section of the wall is collapsed.

(b) Circular cistern in Vrouchas, where section of wall and the concrete crown are collapsed.

Specifically in Vrouchas no major structural problems except in specified areas where either we have the collapse of the masonry (presumably due to human intervention) or severe deformation will lead to future failure (??). Reinforcement is the circular shape of the cisterns and the uniformity of the soil around them. Unlike in Kourounes several parts of the cisterns are damaged. This mainly comes from human intervention and the characteristics of the surrounding soil (coarse sand and clay are impermeable to water, soils with good shear strength and low compressibility). Resulting in the collection of large quantities of water in the surrounding area and the almost complete coverage of the cistern and surrounding area for a long time. In Dilakko we have three cases: Circular tanks with walls of small inclinations to the vertical which are in fairly good condition. A small circular cistern with walls of small negative slope, which raises the question whether it was initially a closed cistern and a large cistern with walls of greater inclination to the vertical, which has largely collapsed. Our investigation is focused to the mechanism of failure which is associated with the geometry of the cistern and the quality of the soil around it, which varies from well-graded sands in areas with squamous limestone. According to surveys it may not have initially circular shape of the wall, but it followed the format established depending on the terrain. According to the results of geophysical survey, the first 12m observe figures given in limestone, then a layer characterized by karst limestone rock with mixtures of clay materials and end regions suggest the existence cavities filled with clay materials or water, and thus a possible communication between adjacent cisterns. These results combined with field observation and the failure mode (collapse of walls in the area showing aluminous soils and an integral wall near the rock formation), suggesting that surround the large cistern based on different qualities of soil in which If there are specific charges (e.g. earthquake loading or human factors) led to failure in the masonry, (??). Also earlier interventions in the crest of the walls proved inadequate.

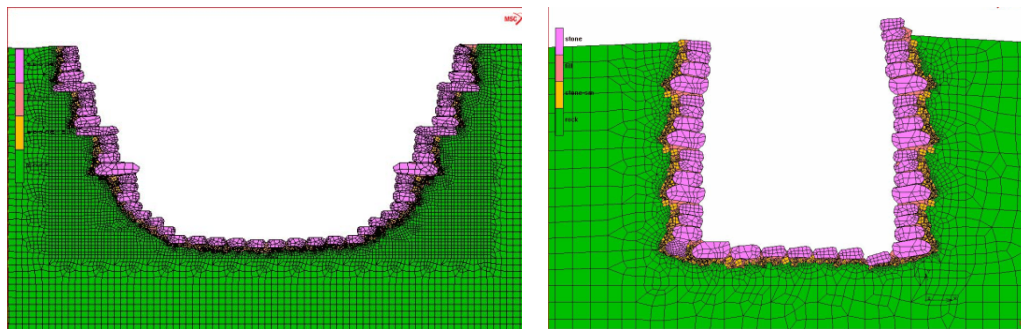
Figure 5

(a) Model A (large cistern, inclination of walls).

(b) Model B (small cistern, vertical walls).

- *Model A*: Detailed simulation was used and the walls of the large cistern were simulated with an inclination to the vertical. Total cistern depth equal to 6.5m (Figure 4a).
- *Model B*: Detailed simulation was used and the walls of the large cistern were simulated with zero inclination to the vertical. Total cistern depth equal to 4.5m

(Figure 4b). Additional two cases were considered, first, *B1*: Continuous model and second, *B2*: Contact model.

- *Model C*: Simplified simulation for masonry using rectangular finite elements was used and contact model was assumed, to *Model A* geometrical model.
- *Model D*: Simplified simulation for masonry using rectangular finite elements was used and contact model was assumed, to *Model B* geometrical model.

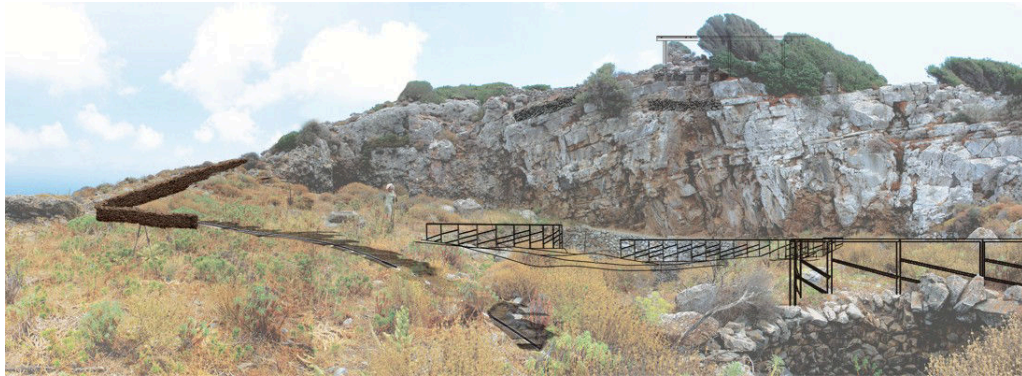
Figure 8: Dilakko cisterns area. The protection rails and the new drystone path.

Our general arrangement rehabilitates the existing cisterns according to the structural study and their perimeter is crowned, according to the proposal, with stone and binding mortar. In Kourounes, new drystone structures are provided, serving the delineation of a large new irregular basin. In this way that will allow the increase in water capacity combined with the restored still existing circular cisterns. Stone pavements, using local material are provided as continuation of the old paths. In selected areas between the circular shapes, a new arrangement is proposed using the local Fourni stone slabs in sizes of 30cm x 5 depth.

Protective railings placed in a circular arrangement will be located at selected parts of the three groups of cisterns. In Kourounes, a raised steel walkway will be built, in relation to the ground level, 28m in length, in order to permit the visit during the winter time. A shading structure will be placed in contact with the large threshing-floor, in the higher point of Dilakko area (Figure 6). This will be a steel structure composed of vertical and horizontal metal elements and wooden planks as final upper overlap (Figure 7).
